Frequently Asked Questions #E8

Question : When I do a DUR on my ML1 there is no data, but the total tip count looks correct ?

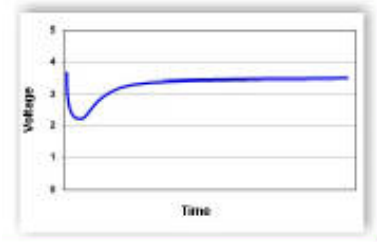
Passivation is a film of lithium chloride (LiCl) that forms on the surface of the lithium anode, and it serves to protect the lithium from discharging on its own when the load is removed from the cell. The film of LiCl, which is essentially a high resistance layer between the electrodes, is primarily responsible for the long shelf life (>10 years) of lithium cells. Passivation may cause voltage delay after a load is placed on the cell as illustrated in the following drawing:

After a load is placed on a cell, the high resistance of the passivation layer causes the cell's voltage to dip.

The ML1 draws most current when it is writing an event to flash memory, and if the battery is suffering from passivation the voltage may dip below the safe operating voltage of the memory chip, causing an error in the data written. When dumping data with the DUR command, an error such as this may cause the dump to prematurely terminate, giving the appearance there is no data.

You can solve this battery “passivation” problem by adding a large capacitor across the power supply, which holds the battery voltage high during the memory write – eliminating the dip in voltage shown above. Hydrological Services will provide a retrofit capacitor module that can be easily fitted in the ML1, as shown in the following photos.
